QA-95
Bordlington
Centreville vicinity
Private

late 18th century

INVENTORY FORM FOR STATE HISTORIC SITES SURVEY

Bordlington

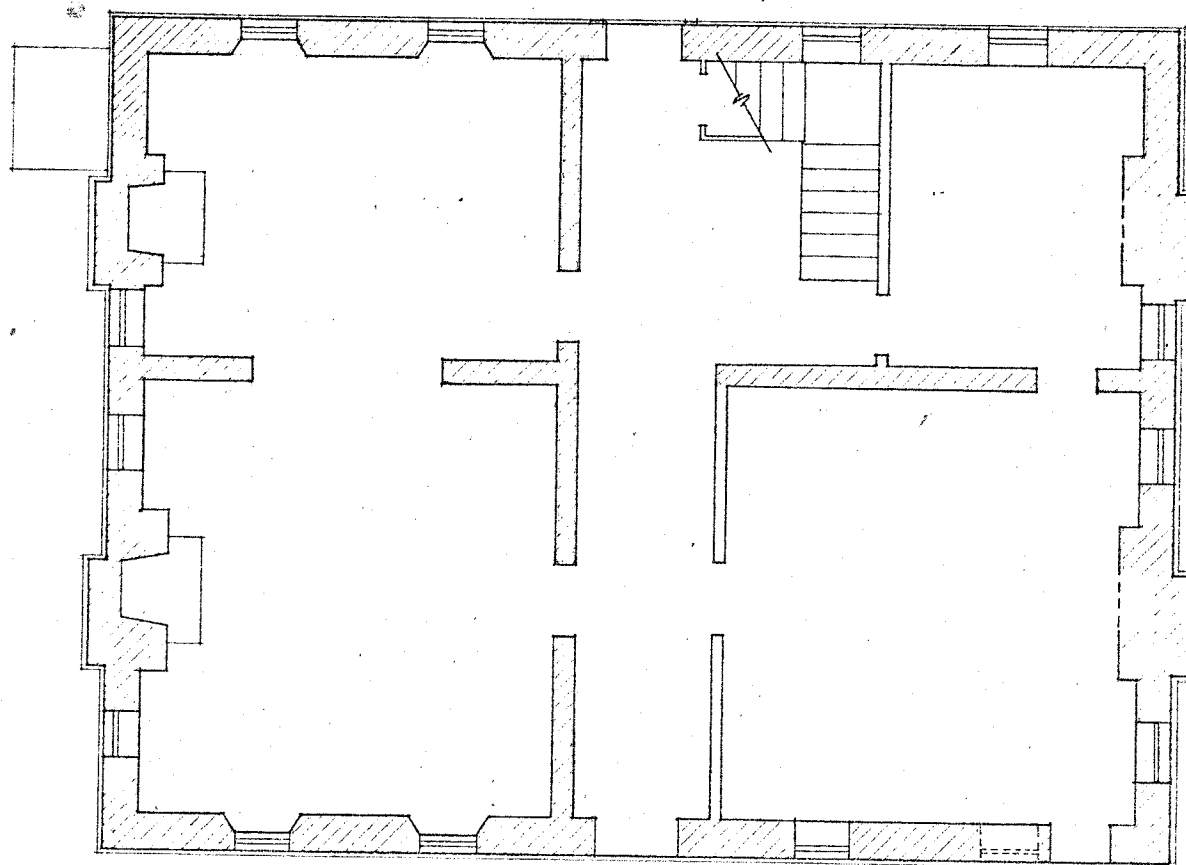
QA-95

0 2 4 6 8 10
SCALE: 1/8" = 1'-0"

BORDLINGTON
CENTREVILLE, MARYLAND

MARCH 21, 1978.

Interior details of interest include much of the original woodwork, all of the first floor mantels, and most of the original doors. The floor plan is an unusual variation of the center hall floor plan with an open stair hall at the rear of the house.

the exterior bulkhead entrance on the south gable. The interior stair has been removed, however. The cellar is divided by brick partition walls into four rooms. The two south rooms correspond to the south rooms on the first floor, but the two north rooms are larger, and also include the area below the first floor hall. The foundation is laid in rough fieldstone below ground level, and the chimney bases have relieving arches with recesses. The interior doorways have beaded frames with the original red paint still exposed. All had doors, but these are now gone. The ceiling joists are pit-sawn from hewn logs. They average 3 x 10, and are laid parallel to the gable on 18-inch centers. The butt ends are set in pockets in the masonry walls and rest on one-inch wood plates embedded in the masonry.
